Orcas Highlands Association

Reserve Study

May 2020

Reserve Study
Executive Summary

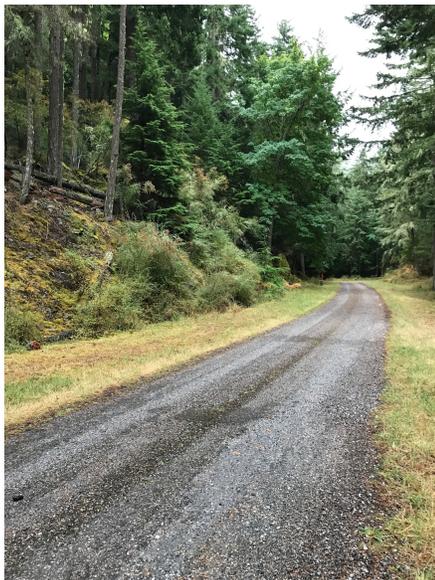
Sub Element 1a: Chip Seal Resurfacing

Useful Life: 8 – 10 years, more on less traveled roads. Severity of winters can influence the life span of the surfacing.

Roadway prior to resurfacing – this section is at the end of its life span.

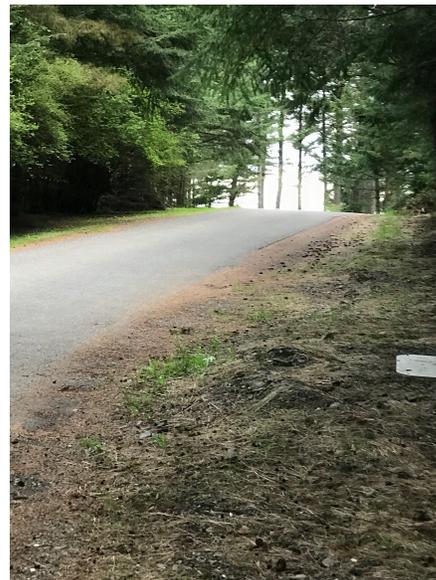
History: Last redone in 2018, engineering walk-through post construction confirmed all roadway surfaces were in good condition and all repairs were made.

Post construction roadway – similar throughout the Highlands. No striping, speed limit 15mph

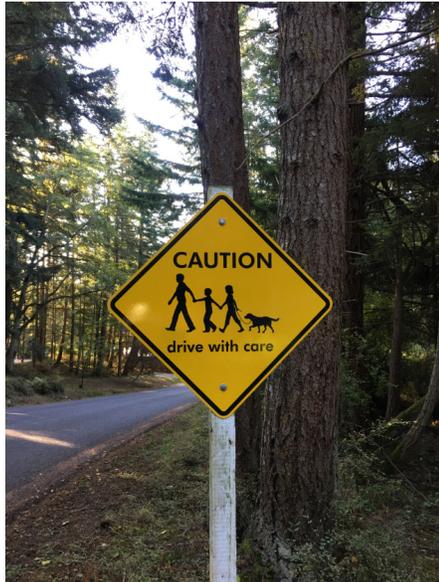
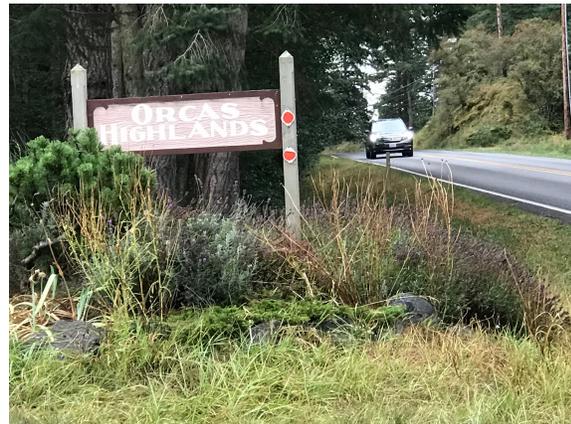
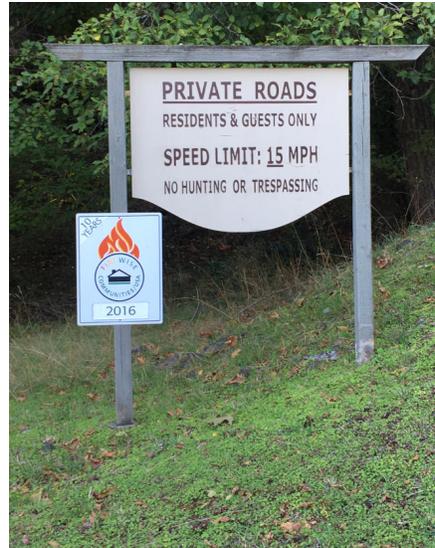
Component 2: Roadway Signs

History: Roadway signage installed 2016.

Comments: Roadway signage is a mix of volunteer made wooden signs and metal reflective roadway signs. This cost addresses the metal signs throughout the Highlands. Signs also included warning posts at steep road edge on Switchback Road.

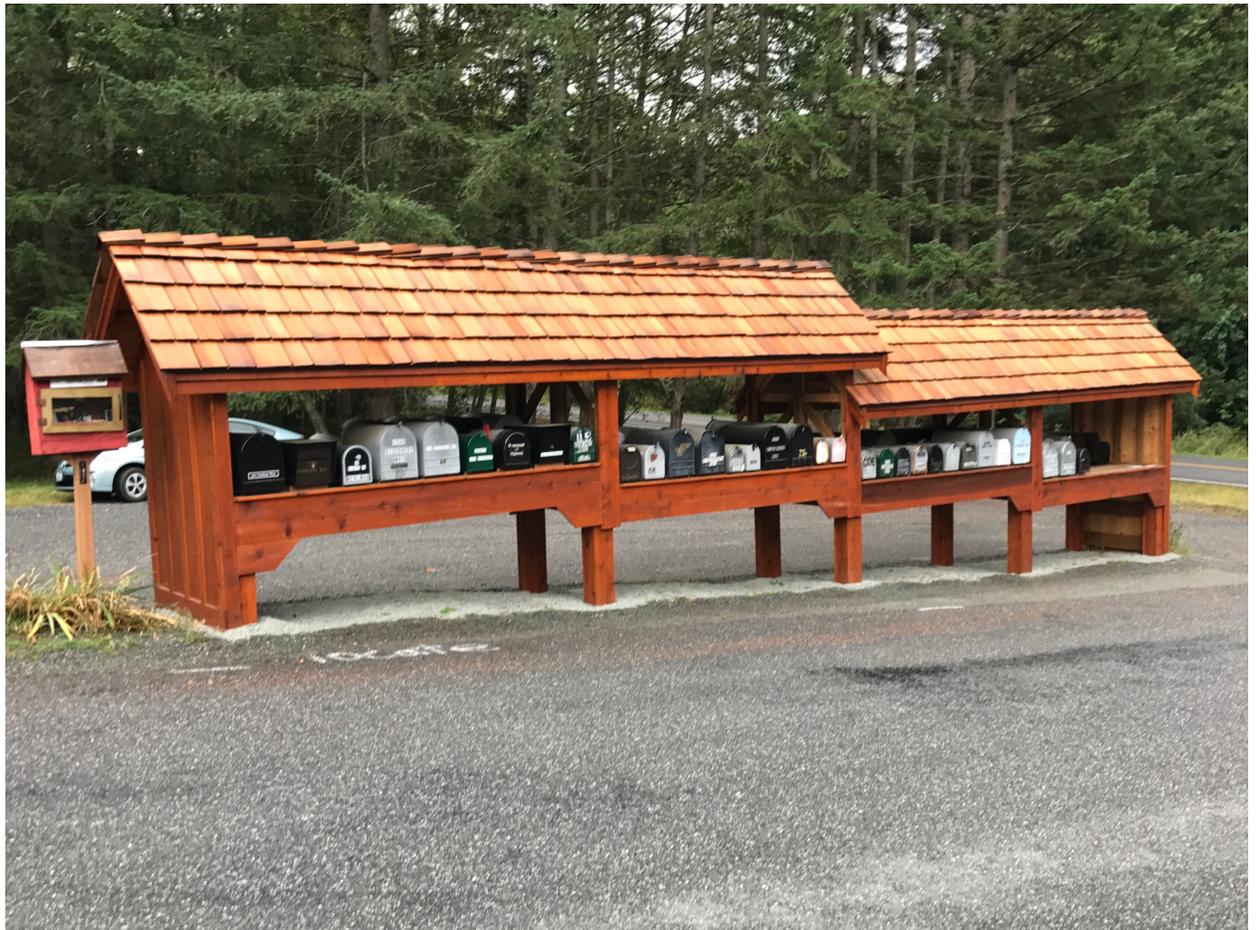
Component 3: Mailbox Station

History: Complete reconstruction in 2018

Comments: Structure built to commercial standards with treated timbers. Only contracted maintenance projected in next 30 years is reroofing. Volunteers paint and maintain the structure annually.

Cost Estimate: Reroofing and minor repair estimated at \$8,000
